## Colony Extraction from a Porch Ceiling in a T.Wells Property.

**Work carried out in July 2020 by Sarah & John, [the Seal/Kemsing colony extraction team].**

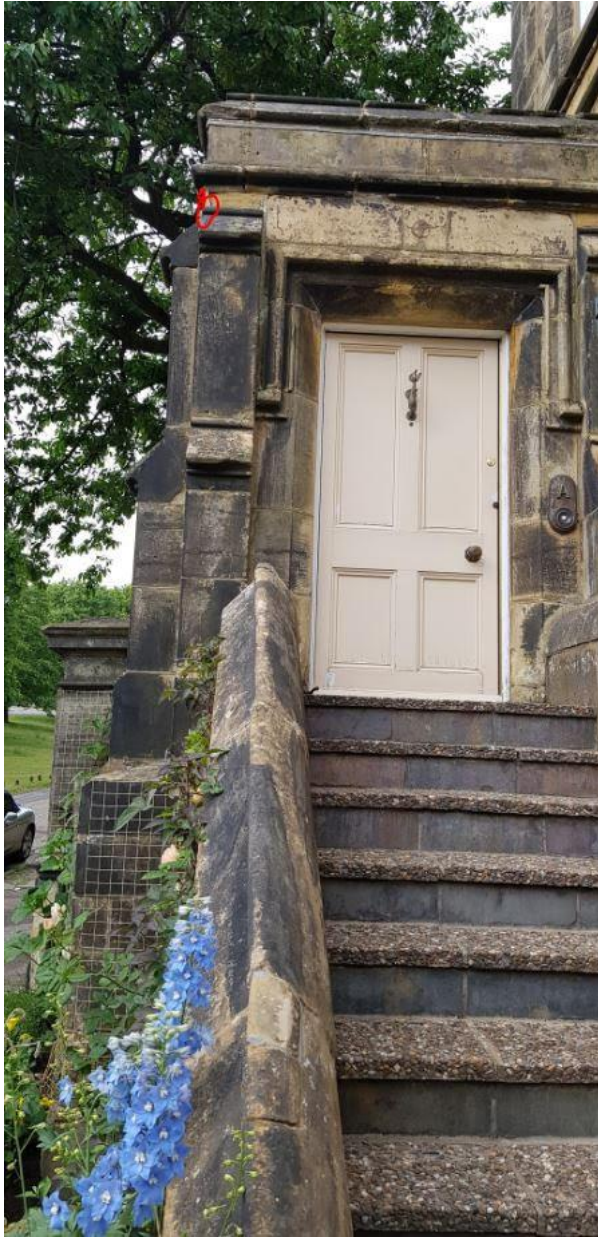
This historic Tunbridge Wells property is now divided into 12 modern flats and bees were entering the porch of one of these flats, highlighted by the red circle.

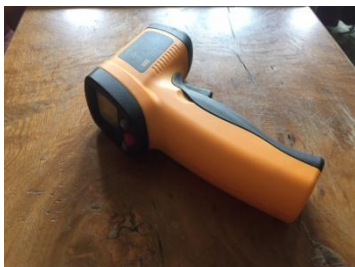
Initially we used this infrared gun to check any increase in the surface temperature of the porch ceiling to establish the size of the brood nest. It also usefully gave us an idea where the rafters were positioned.

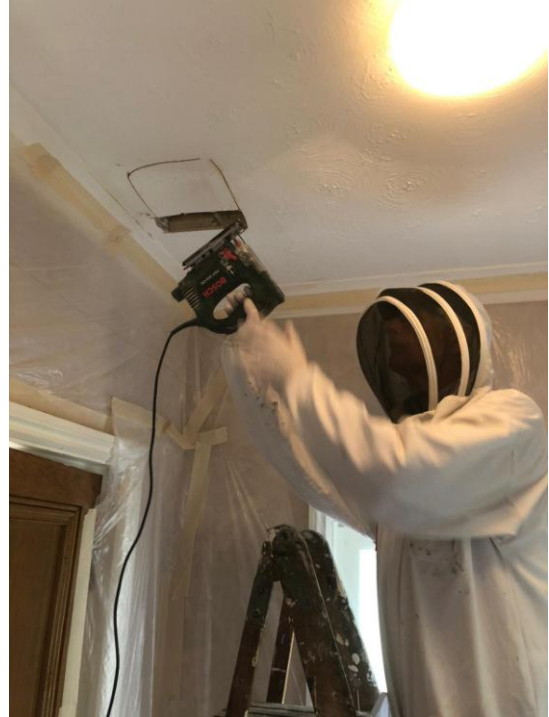
John used a jig saw to make the first cut downstream of the brood.

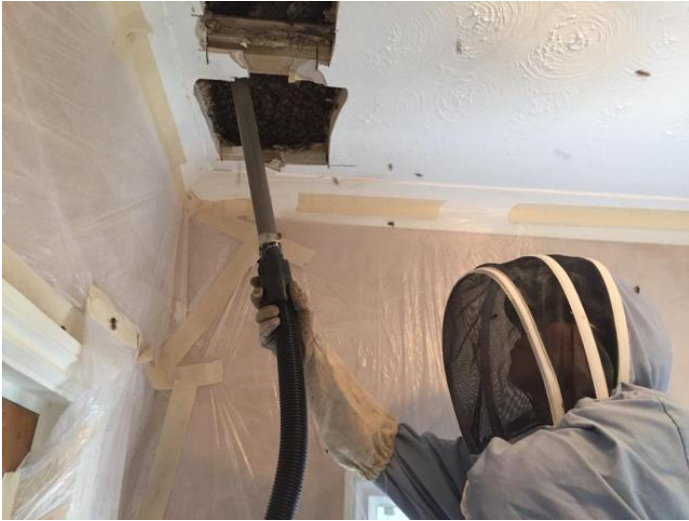
This initial hole was enlarged downstream of the colony, so we could insert foam to block the escape of the queen further down the cavity.

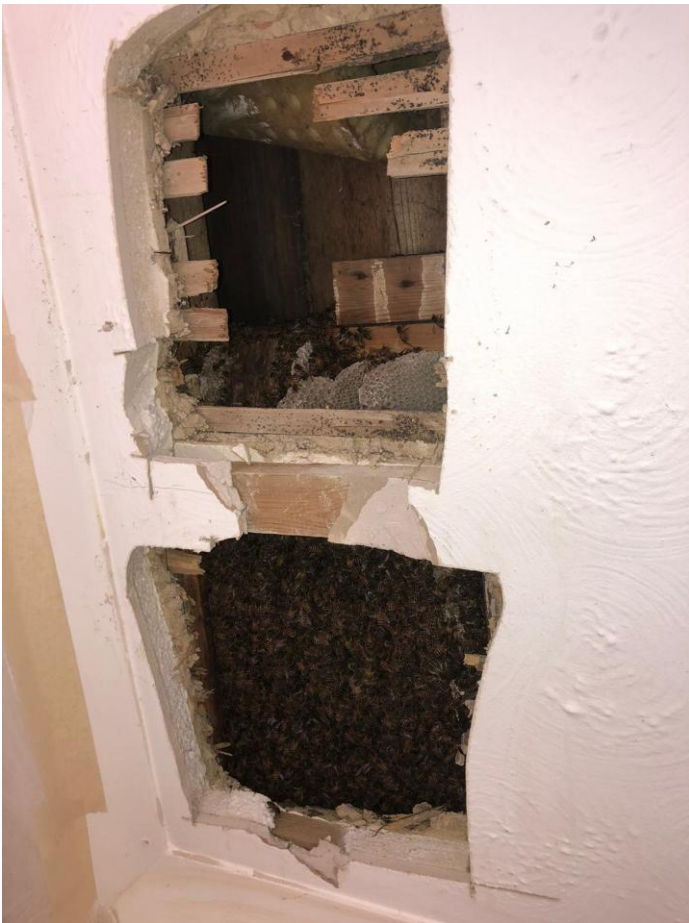
This shows the exposed honeycomb of part of the colony. The colony also extended into the porch overhang, which is hidden from this view.

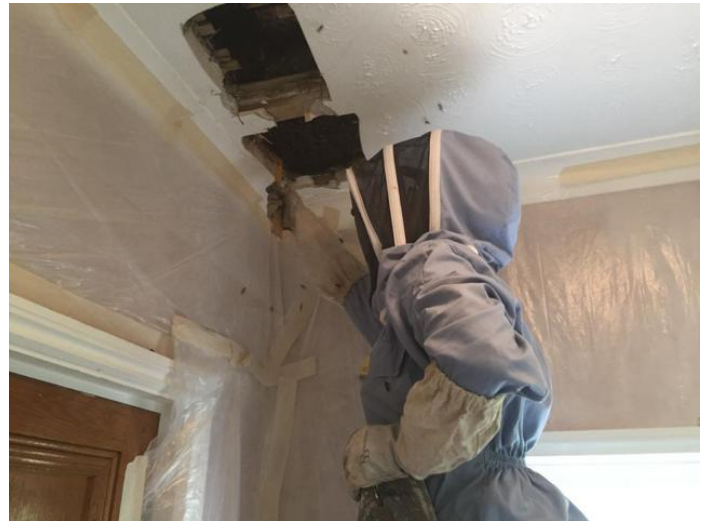
The four different layers of ceiling illustrate the work that has taken place on the ceiling during the lifetime of this property. The top layer was modern plasterboard, then foam, hard plaster and finally the original lathe & plaster layer. All of which the jigsaw had to cut through.
